Antelope Guzzler Report
Cisco Guzzlers Maintenance Report 2012

2012 Summary of Future Repair & Maintenance Needs

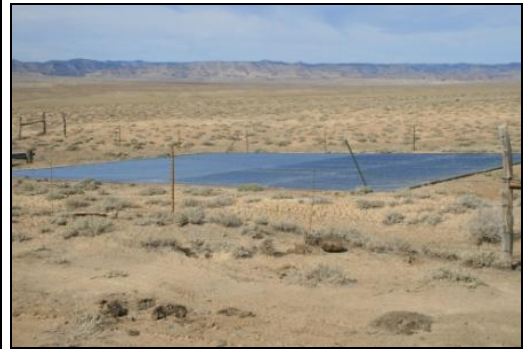
Repairing pitted catchment surface

2012 – The 2' X 6' ground base was replaced and a new corrugated surface installed on ground catchment with the help of dedicated hunters. Gutter had large hole in it that resulted in no water being collected. Gutter was repaired. Recreation & their water tender filled the water storage tank. System was turned on in the spring and turned back off in the fall when the cows returned to the range. Sediment box was pumped out, cleaned and inspected. Storage tank is totally full of water and system is in good shape.

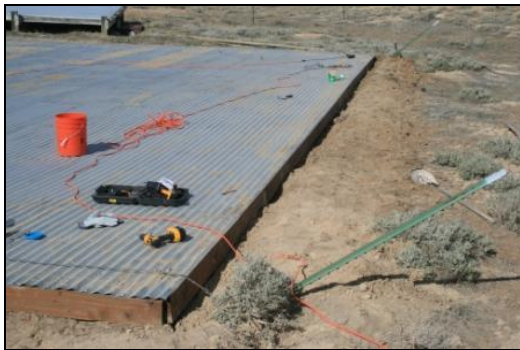
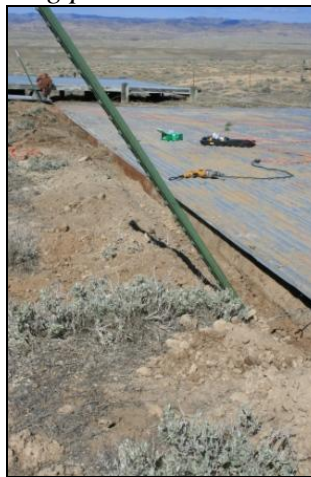
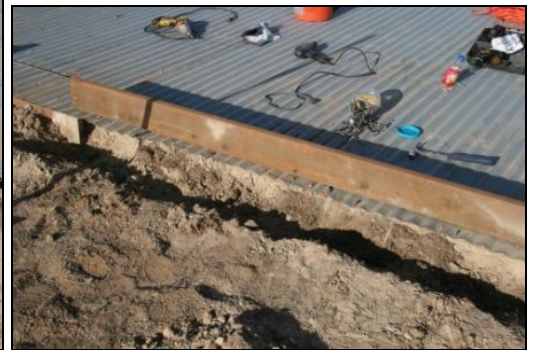
Replacing 2' X 6' Base

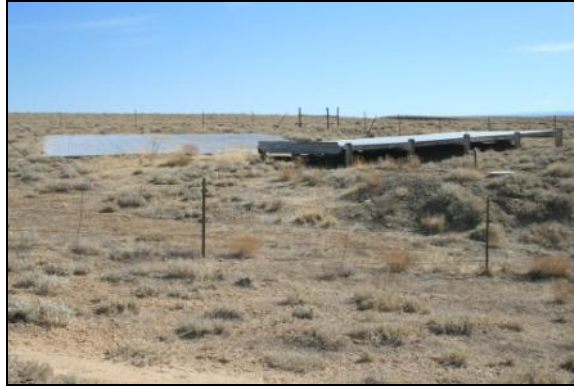
2007- Refurbishment started

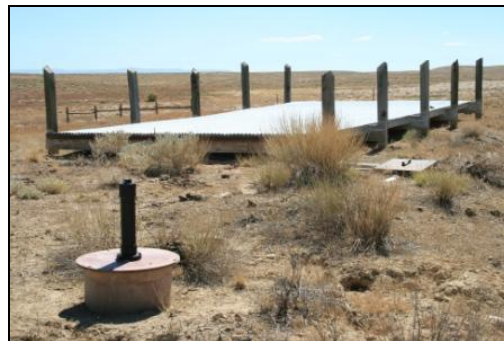
#2 East Harley

2012 - System was turned on in the spring and turned back off in the fall when the cows returned to the range. Sediment box was pumped out, cleaned and inspected. Storage tank has water and system is in good shape.

2011 - System full of water and in good shape.

2010- Storage tank full. New gutter, drip edge and fill spout installed. Re-furbished plumbing from gutter to sediment tank. New drinker, plumbing installed & locks. Hunting blind removed.

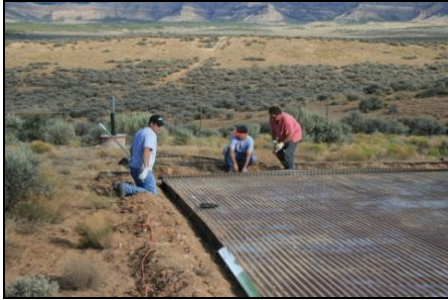
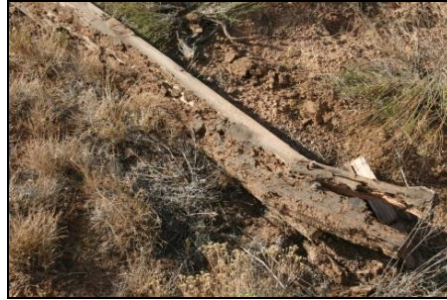
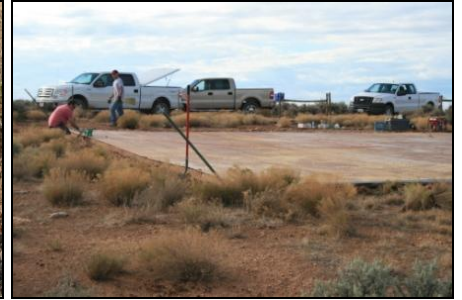
#3 Stateline

2012 - The 2' X '6' ground base was replaced, catchment deck repaired and gutter screen with the help of dedicated hunters. System was turned on in the spring and turned back off in the fall. Storage tank is totally full of water and system is in good shape. Sediment box was pumped out, cleaned and inspected. Storage tank has water and system is in good shape.

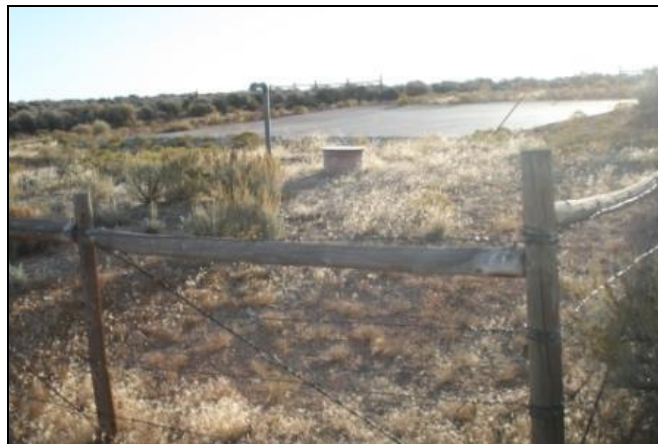
2008-Tank has water. No lock on drinker or locking grate. Edge of catchment exposed and is at risk of being blown away!

2009- Storage tank has water. New drinker installed and re-plumbed, holes back-filled around base of catchment, sediment tank. Brush cleared up.

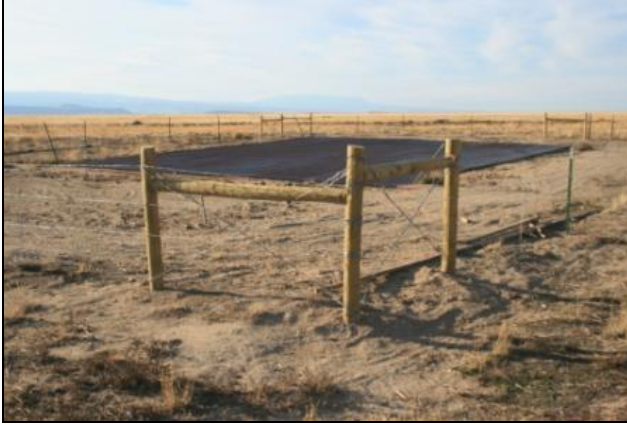
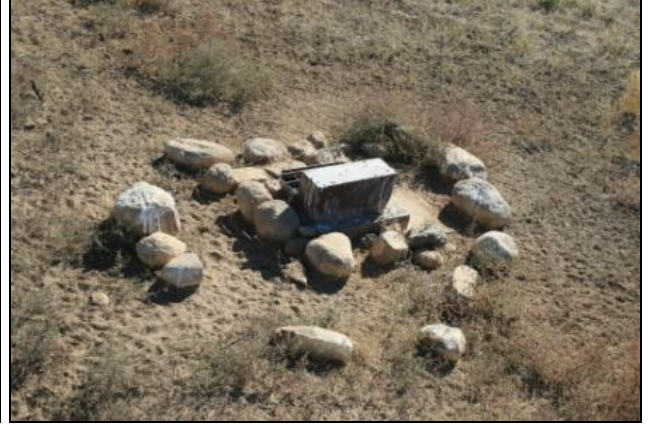
#4 Top of Sage (Bitter Creek)

2012 - System was turned on in the spring and turned back off in the fall when the cows returned to the range. Sediment box was pumped out, cleaned and inspected. Storage tank has water and system is in good shape.

2008 – Water off and disconnected, no water reaching drinker. Needs storage tank replaced. No locks on anything. New screen system on gutter, gutter cleaned

2009-Major overhaul completed: New water storage tank, sediment box, drinker, valves and valve box, fill spout, over flow & plumbing installed, catchment base refurbished and a new fence was built. Extensive use by pronghorn was noted once system went back on-line in late July.

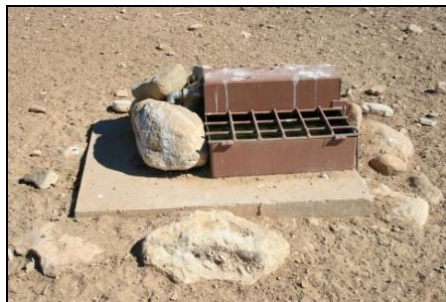
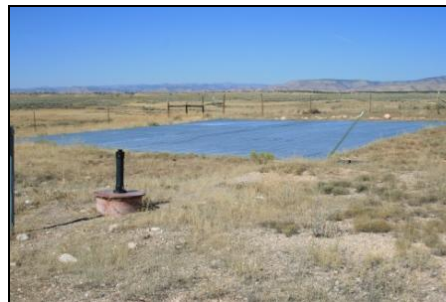
#5 Sheep Camp South

2012 - System was turned on in the spring and turned back off in the fall when the cows returned to the range. Sediment box was pumped out, cleaned and inspected. Storage tank has water and system is in good shape.

2009-In 2007 this system was functioning, but the catchment was in need of repair and the corrugated metal needed to be refurbished. Due to limited funding in 2007 these repairs were scheduled in 2008, but, unfortunately we did not get the repairs done in time. High wind in the spring of 2008 destroyed the rain catchment. The water storage tank and drinker is still working and we delivered water to the system, but this is costly. Where the catchment once was is a very flat, packed surface. The following spring (2009), upon inspection and system turn-on Kevin found the remainder of the system had been vandalized. The T-bar that locked the shut-off valve had been cut and the water had been turned on. With water in the drinker all winter, large numbers of cattle had used the water drinker. This resulted in the drinker being twisted and bent and all the water drained from the previously full tank. Most of the vegetation was tramped in the area. Fortunately there was no damage to the under-ground plumbing and the fence was still intact so the flat surface was the catchment had been was still ready for a new catchment. Kevin blocked the pipes leading to the tank so excess sediment did not enter the tank.

During the summer of 2009 the catchment base & surface was re-constructed and locks were installed on the drinker & shutoff valve and the sediment box was thoroughly cleaned. Recreation's water tender then filled the tank and the system was operational thru the summer. The system was inspected; its condition documented and shut down for the winter.

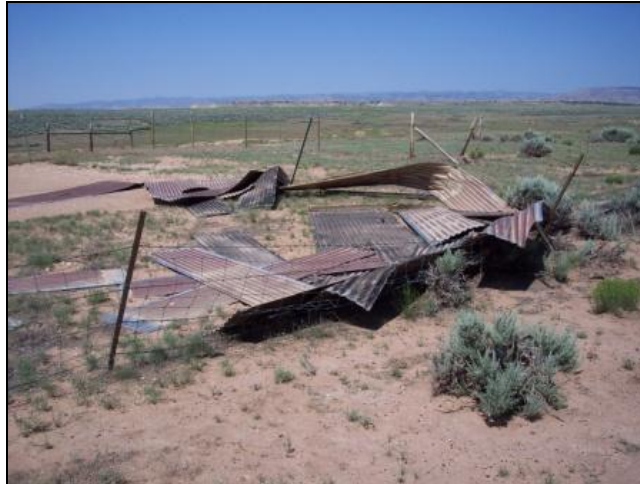
2008-catchment after it blew away

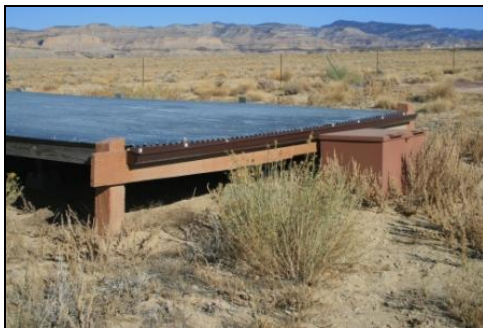
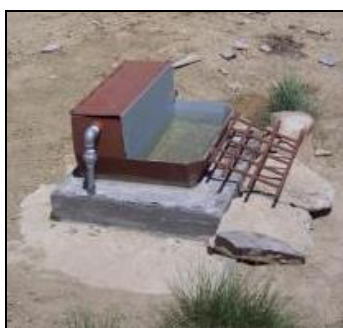
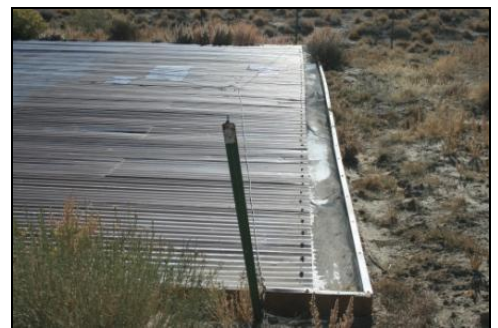
2008 - In 2004 the water storage tank became filled with sediment and the system no longer functioned. In 2005 the BLM purchased a new storage tank and in 2006 the DWR installed this 1000 gallon tank and filled it. By 2006 the tank was dry and never seemed to hold water and there was a presumed leak.

Many other problems existed with this system so it was over hauled & refurbished, including the installation of a new sediment tank, fill valve, overflow valve, drinker, gutter &, drip edge. The new storage tank dug up & a leak in the bulkhead was found and repaired. The upper catchment had additional support structures installed to the base and the lower catchment base re-furbished and repaired. The fence was also repaired and all wood was painted.

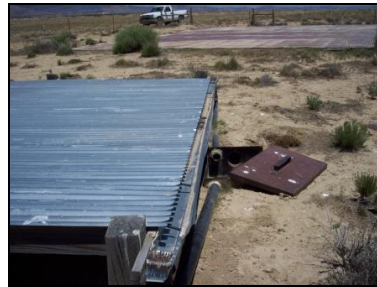
2007

2007- Storage tank empty – Non-functional
2006 – New storage installed & filled but later was empty
2005 - Storage tank empty – Non-functional

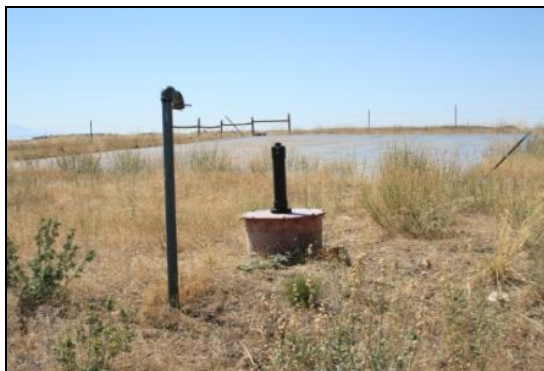
#7 Bird Finger (Bryson)

2012 - The 2' X '6' ground base was replaced, catchment deck repaired and gutter screen with the help of dedicated hunters. System was turned on in the spring and turned back off in the fall. Sediment box was pumped out, cleaned and inspected. Storage tank has water and system is in good shape. Storage tank is totally full of water and system is in good shape.

2011- Storage tank full of water and system is in good shape.
2010- New drinker and fill spout installed and drinker in now locked. Heavy pronghorn use.
2009- Sediment tank cleaned, catchment base backfilled and rocks placed around base to prevent sheet metal from blowing away. Drinker needs replaced.

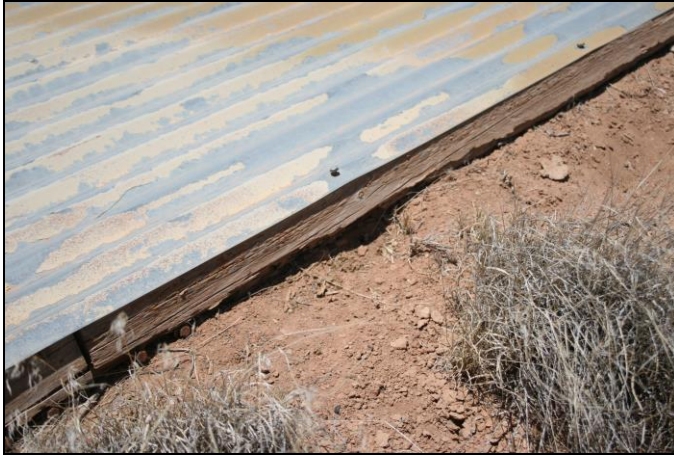
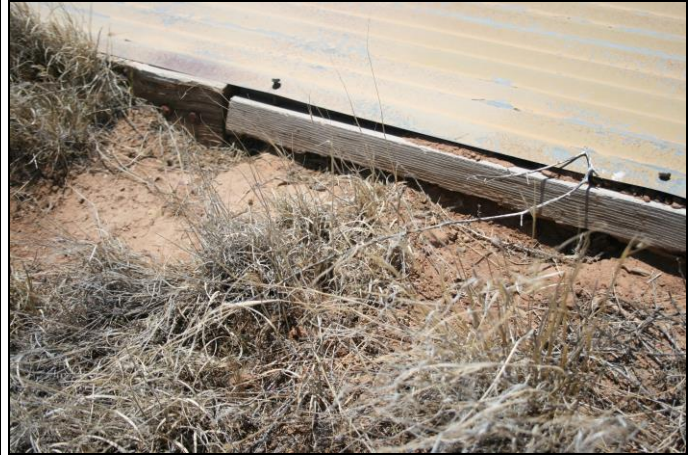
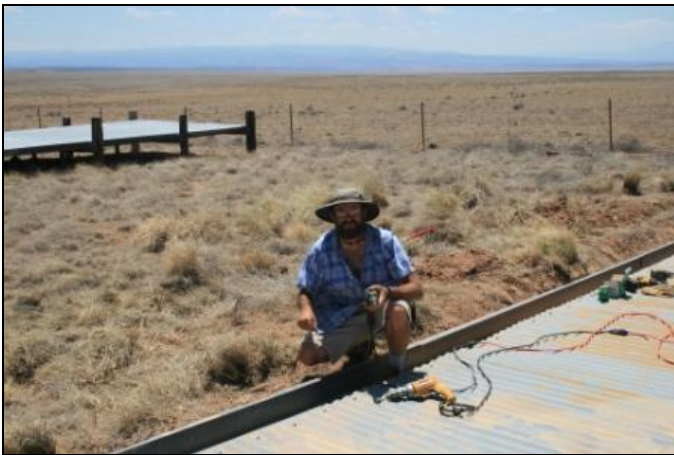
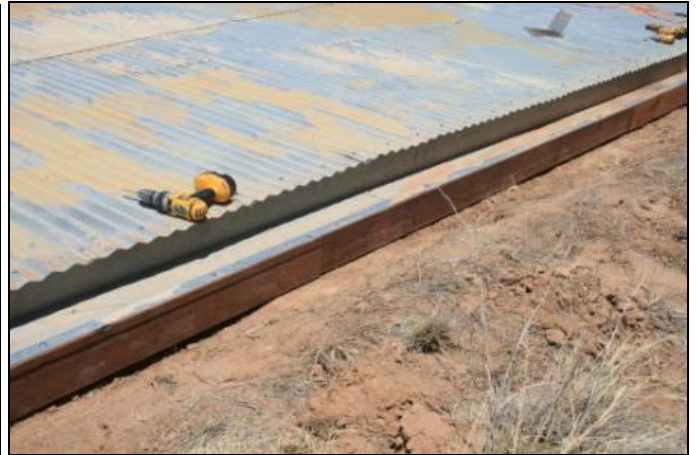
#8 Dozer Blade

2012 - The 2' X '6' ground base was replaced, catchment deck repaired and gutter screen with the help of dedicated hunters. Tank was very low on water, discovered a water line from the storage tank had pulled apart, allowing all the water to drain out. The line was dug up and replaced. Recreation then came out and filled the storage tank. Sediment box was pumped out, cleaned and inspected. Sediment box was

pumped out, cleaned and inspected. System was turned on in the spring and turned back off in the fall. Storage has water and system is in good shape.

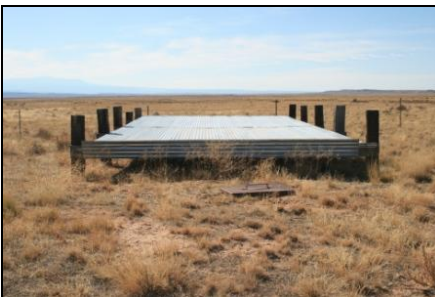
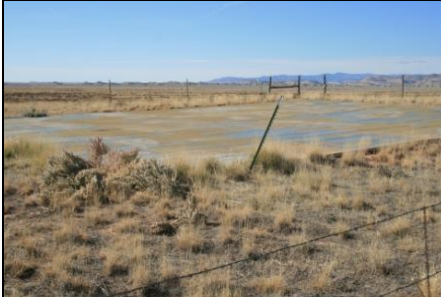
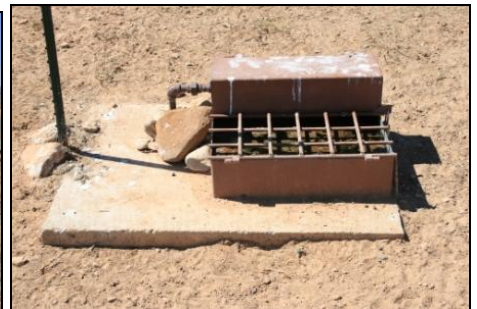
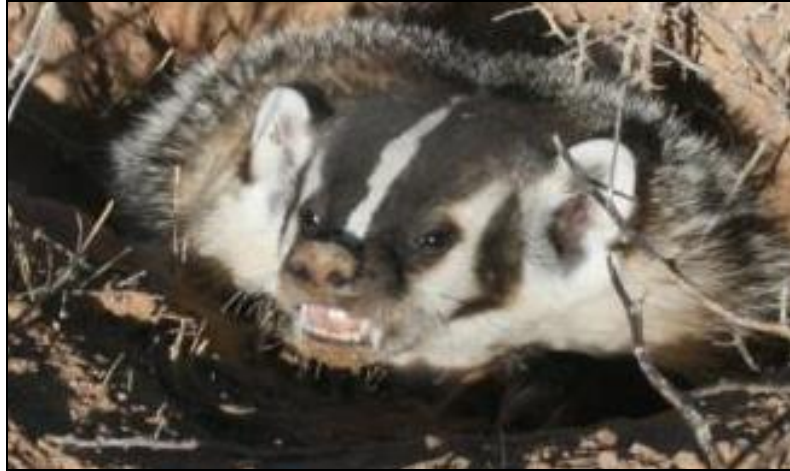
2011 – Damage from a badger den - deck was jacked up; the hole filled, re-blocked and braced.

2010- Heavy winter snows damaged upper catchment. Catchment was jacked up and addition support was installed. New drinker and fill spout installed and drinker is now locked. Good pronghorn use.

2006 - Water was low, repaired a broken drain spout

2008-Tank full.. Repaired upright catchment with deck blocks and a new center support, filled holes around settling tank & catchment and fixed tank lid.

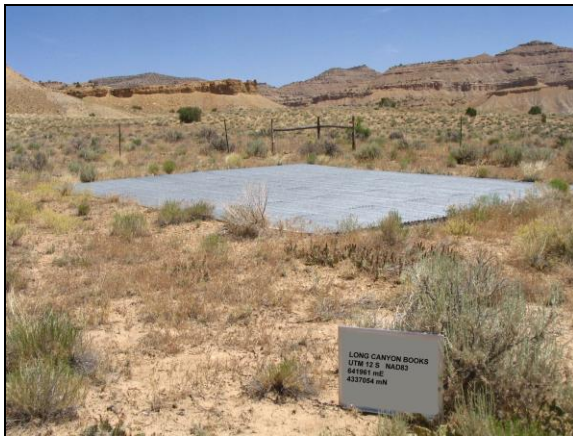
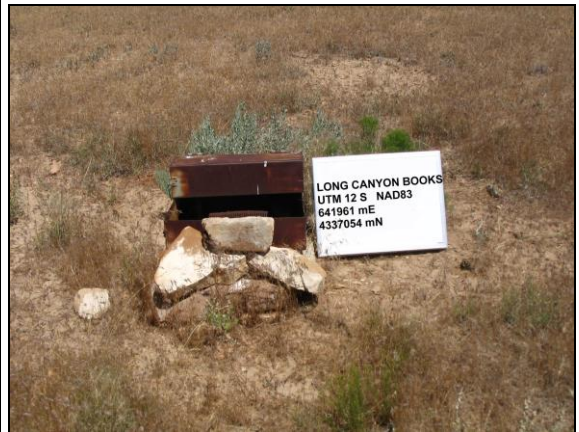
#9 Cottonwood/Long Canyon (Blaze)

2012 - Storage tank is fairly full of water. System was turned on in the spring and turned back off in the fall when the cows returned to the range. Sediment box was pumped out, cleaned and inspected.

2009, 2010, 2011- Storage tank full, drinker was cleaned out.

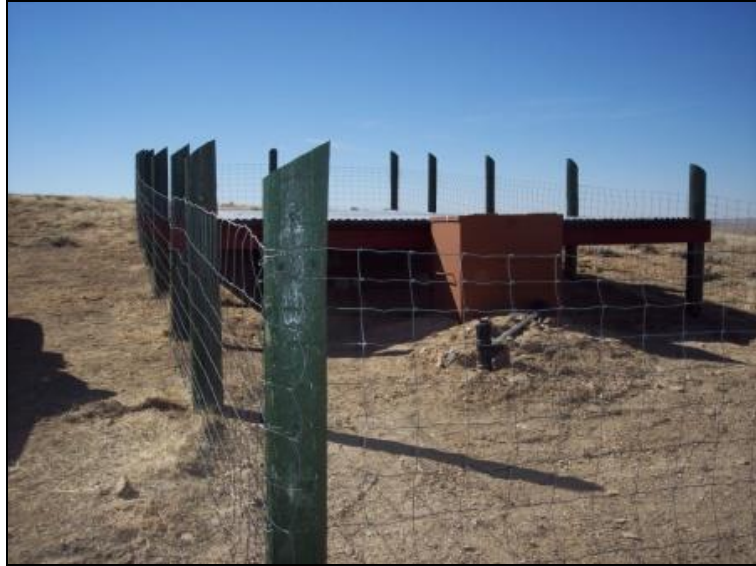
#10 East Cisco South

2012 - System was turned on in the spring and turned back off in the fall when the cows returned to the range. Sediment box was pumped out, cleaned and inspected. Storage tank has water and system is in good shape.

2008, 2009, 2010, 2011- Storage tank is full. New sediment tank installed, drinker cleaned. System working well.

2007 System refurbishment – Catchment surface patched and repaired added additional support to apron & leveled, new gutter, flashing & drip edge installed, new drinker & plumbing installed, new valve box & shut off valve installed, fence repaired and painted.

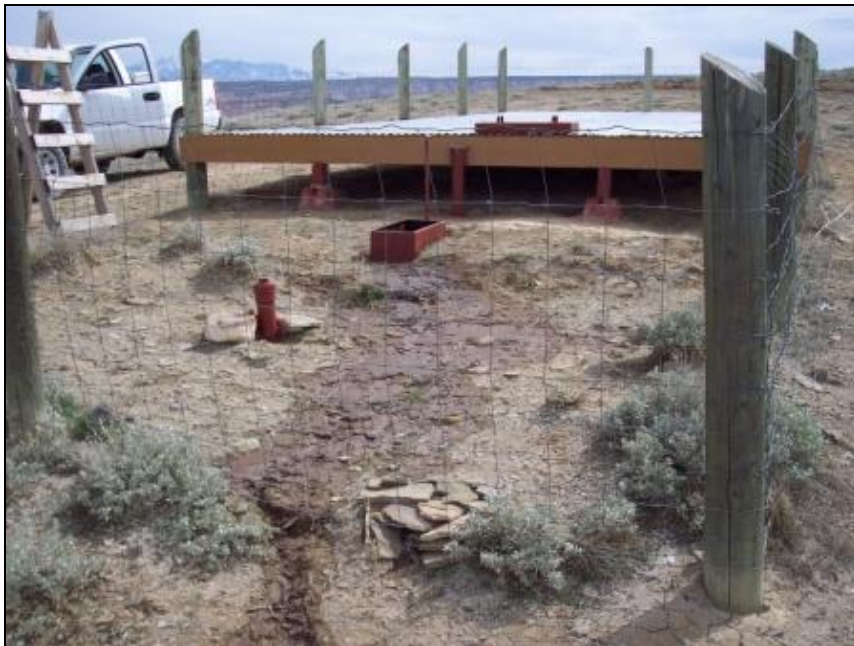
#11 West Cisco South

2012 - System was turned on in the spring and turned back off in the fall when the cows returned to the range. Sediment box was pumped out, cleaned and inspected. Storage tank has water and system is in good shape.

2009, 2010, 2011- Storage tank is full. . System working well.

2008- System Refurbishment - Catchment jacked up and leveled with deck blocks and re-painted, Apron patched, new gutter system installed, shut-off valve leak re-paired, repaired valve to valve box drain, replaced turn off valve, installed new drinker and re-stretched

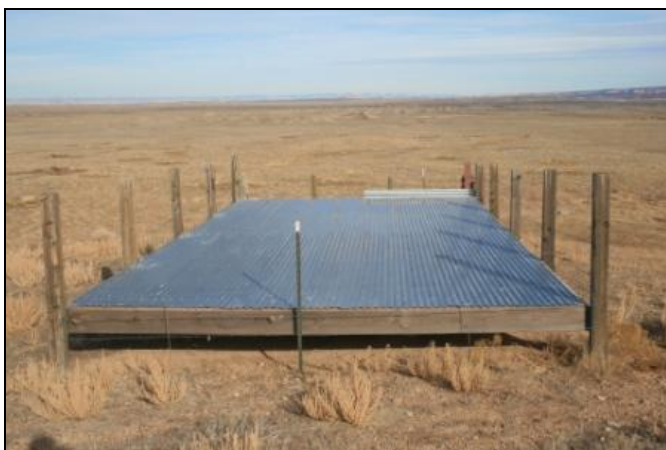
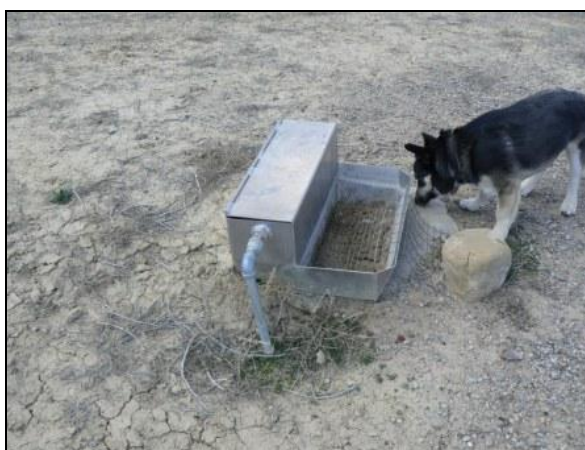
#12 UDOT

2012 - System was turned on in the spring and turned back off in the fall when the cows returned to the range. A new power coated/ rhino lined drinker was installed on a cement base. Locks were placed on the system. Sediment box was pumped out, cleaned and inspected. Storage tank has water and system is in good shape.

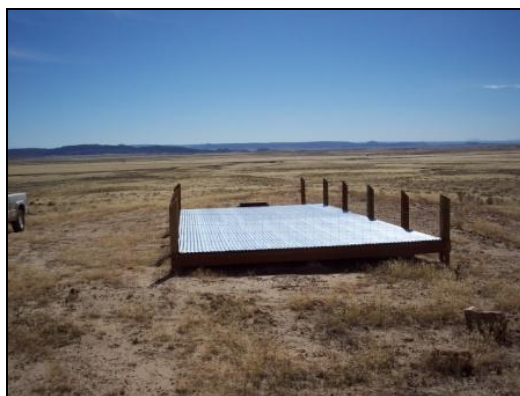
#13 DOE Guzzler (funded by DOE & Stoller installed 2006)

2012 - System was turned on in the spring and turned back off in the fall when the cows returned to the range. Sediment box was pumped out, cleaned and inspected. Storage tank has water and system is in good shape.

2008 Both locks have been cut? Lock on settling tank ok. Fence loose.

2010- Storage tank is full. Drinker hinges were failing, new drinker and cement pad was installed.

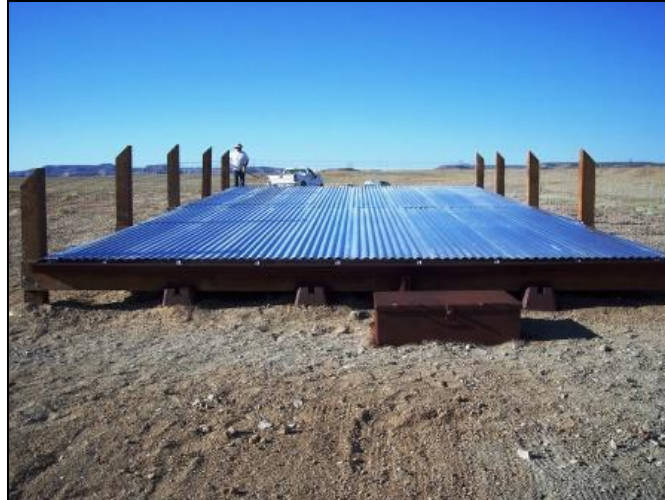
#15 Airport Antelope Guzzler (Funded by Delta Petroleum installed 2008)

2012 - System was turned on in the spring and turned back off in the fall when the cows returned to the range. Sediment box was pumped out, cleaned and inspected. Storage tank is totally full of water and system is in good shape.

2010-- Storage tank very full. During spring inspections a leak was found in the water line between the valve box and the drinker, so luckily no water was lost during the winter as the system was turned off. Line was dug up and repaired and a new gutter screen was installed. Little pronghorn use.

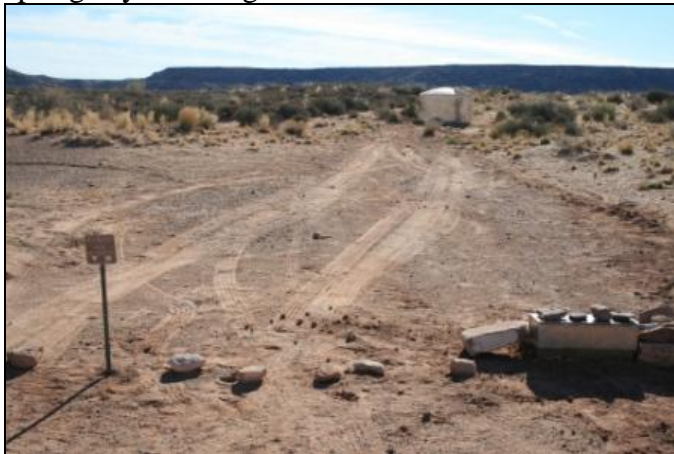
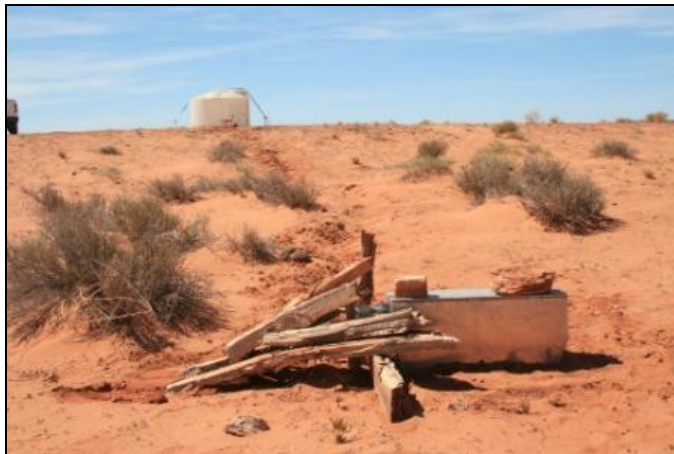
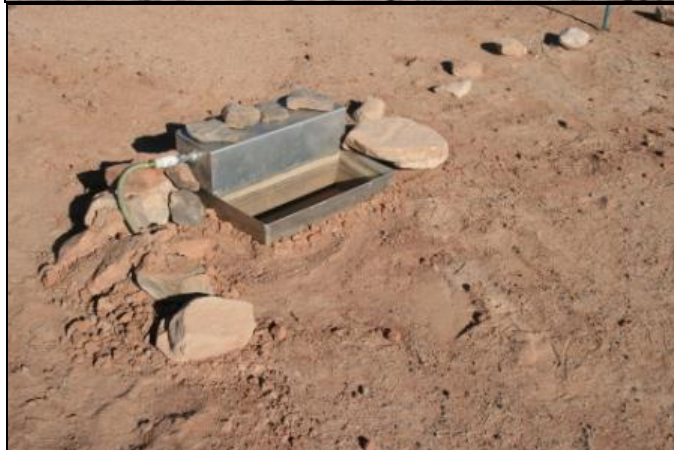
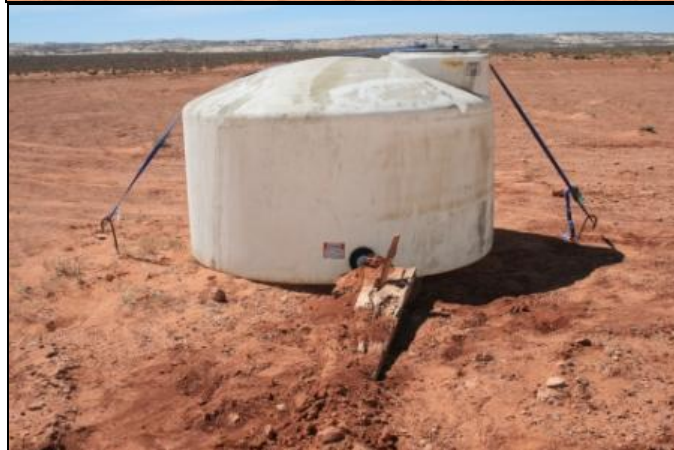
Temporary Water

Minimal precipitation during the 2011/2012 winter followed by severe drought condition in the spring/summer of 2012 lead to altered movement patterns in the Big Flat area of the Cisco Desert. This area offers matt salt desert shrub-brush flats with numerous stock ponds north and south of Interstate 70 where antelope are typically seen. Vegetation and water was nonexistent by early spring and there are no antelope water developments or guzzlers in this area. Antelope were often seen to the south in the sandy, more rolling county that borders the Potash Bighorn sheep area. In these areas the sandy soils and lack of grazing in some areas last year offer better forging opportunities but water was still lacking, as all pond were dry. In these areas four temporary guzzlers were placed to reduce the need to travel to search for non-existent water. Several other temporary water sources were place to the north of I-70 near Thompson Springs by AJ Rodgers.

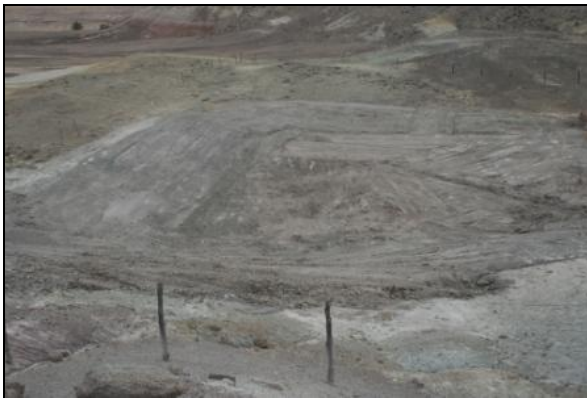
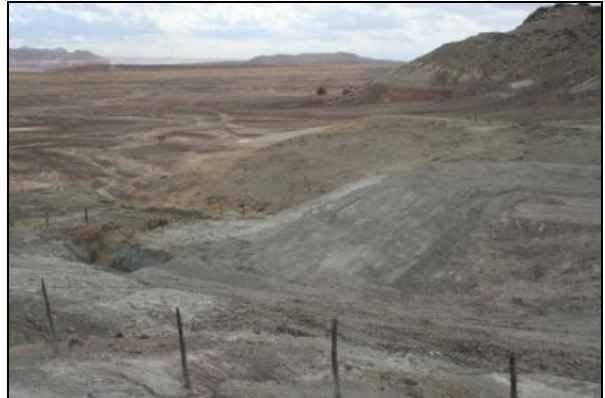
Pond Improvements

Mineral exploration in the Duma Point area, south of where antelope were utilizing the Big Flat areas, a local company with a backhoe was doing some road work for a drilling operation. Working with Kevin was required due to some bighorn sheep concerns. Once this project was done, the operator of the backhoe inquired if he could help with any wildlife needs. Kevin directed him to a blown out pond that in past years provided year-long water for both cattle and antelope. He promptly repaired the pond so that when the rains comes it will hold water. Since that time the local permittee of both that allotment and an adjacent allotment has hired the operator to clean and repair all their ponds!!

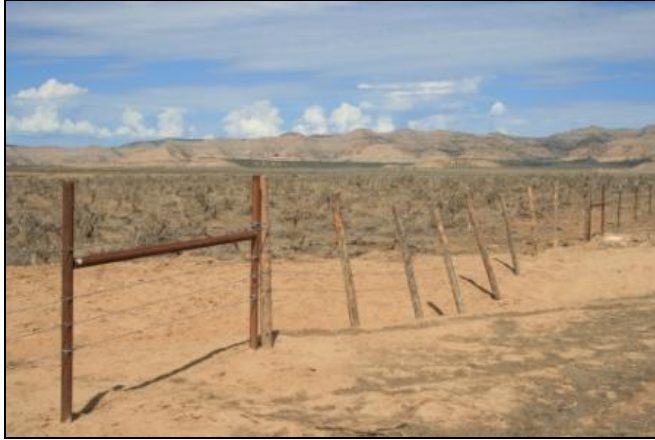
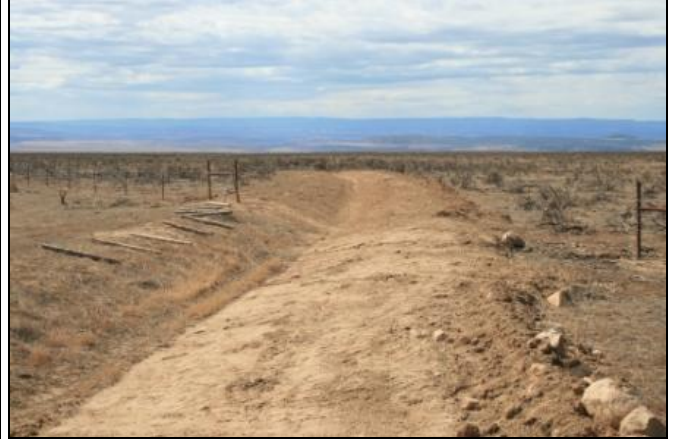
Drop-down Fences

To the northeast of I-70 on the Colorado border a habitat restoration/cheatgrass reduction project was initiated in 2010 to improve antelope habitat. To protect seeding efforts and to facilitate a future rest/rotation grazing plan, UGIP funded the permittee to build four miles of new fencing. To facilitate antelope passage the fence was designed so antelope can easily pass under the fence and large drop-down fences were installed. These fences are only up from March to May if cattle are utilized that pasture.

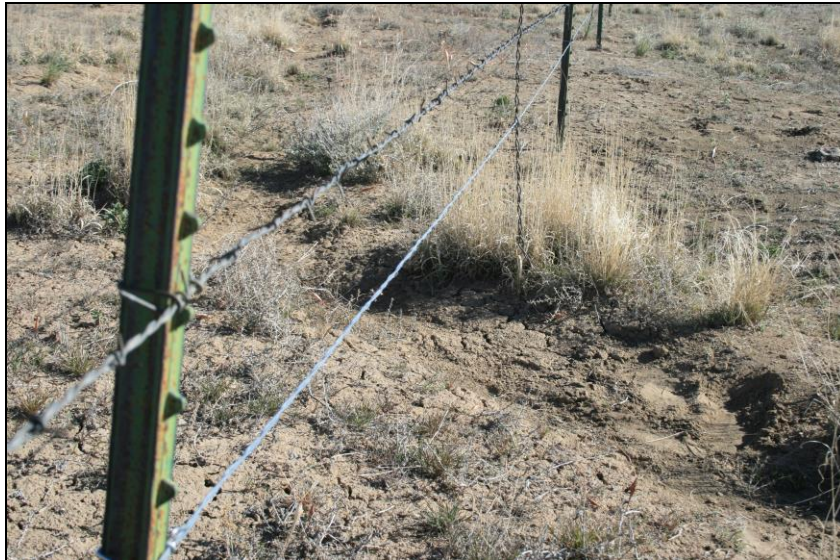
*Note chunks of fur and tracks when antelope pushed under the low, attached barbed fence wire.
This fence was later up-graded*

The Moab BLM continues to identify and upgrade fencing to allow for antelope passage by replacing the lower barb wire with smooth wire, insuring the lower wire in at least 18 inches from the ground and not attaching the lower smooth wire to the fence stays. During the 2012 drought antelope were seen often attempting with much difficulty to pass through range fencing to travel to water or forage. With the help of the local Youth Corps one mile of fences was improved near the Airport Guzzler.
